OVERHEAD TRANSMISSION

Avalanche Damage Triggers Constructability Improvements

The forces of nature can be an extreme challenge when it comes to engineering transmission lines.

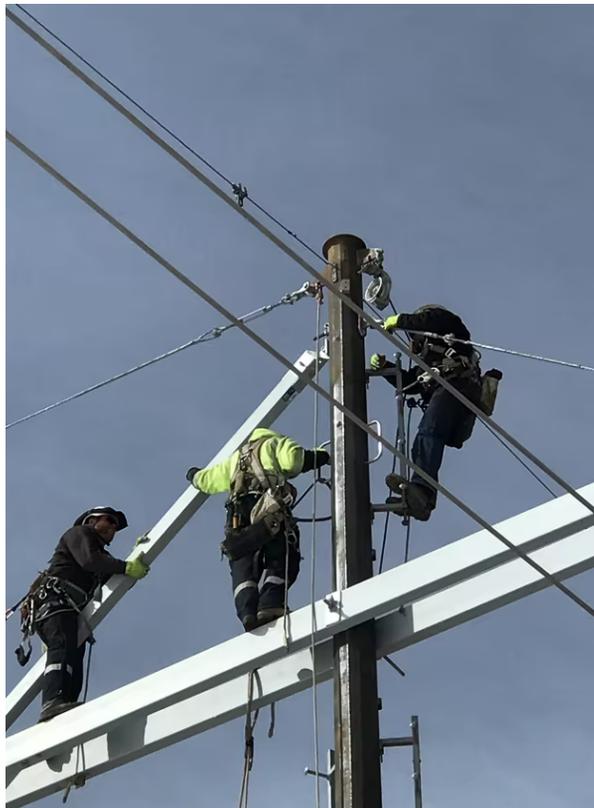
Crews climbing and working off of removable ladders.

The start of the constructive feedback happened one day as a lineman was working from ladders placed on one side of the pole shaft while trying to drill the hole for the X-brace on the opposite side of the pole. The feedback called down to the engineer was somewhat inaudible but was assumed to be politely asserting the difficulty in drilling the hole in quarter inch steel from the opposite side of the pole shaft. The point was taken and spurred further discussion with the crew onsite about how engineering could modify their design to make working in these conditions easier and safer.

Ladder clips are common practice for remote access structures and are most often detailed on structure drawings as being mounted up a climbing face and at working points. Xcel Energy specifies that working ladder clips be placed in four quadrants around the pole at each working point (arm attachments, wire attachments, pole joints, etc.). When a pole shaft has a circumference that is too small at a working point, the steel vendor will reduce the number of working clips around the pole. This potentially results in not having adequate ladder space where a lineman needs to work.

To improve ladder clip design the engineer should clearly define all working points on the drawings that will need ladder clips, including X-brace attachments if they need to be drilled. Also verify adequate ladder clips are available to connect ladders while moving over crossarms.

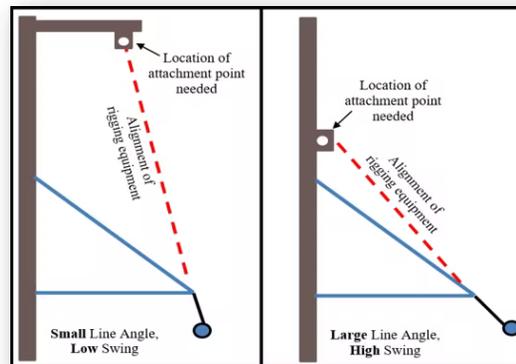
Wire rigging needs on transmission structures with only helicopter access.

Adequate attachments for wire rigging was also an issue on the angle structures. The angle structures that were replaced with monopoles had braced post insulators with a bundle yoke. These structures had line angles of approximately 8 degrees. The new wire was strung with the traveler hanging on the bottom hole of the yoke plate. To transition the wire from the traveler to the wire clamps the wire needs to be temporarily rigged back to a fixed point on the structure.

Normally the wire could be picked up with a crane or bucket truck jib, except the site couldn't accommodate that equipment. With the braced post configuration and only a two-hole shield wire vang at the top of the pole there was nothing to attach the rigging to that would keep the wire at the position needed to pin to the yoke plate. With a tighter line angle the wire could have been rigged off the pole shaft or shield wire vang because it would pull outward more horizontally. With a smaller line angle the wire hangs more vertically, which means the rigging needs to attach more inline vertically above the wire, to possibly a shield wire arm. Since there was not a suitable rigging point, the crew had to use a combination of ropes with the helicopter pulling on the conductor to get the wire from the traveler into the clamps.

All wires that need to be moved from an old position, or from a traveler, to the new pinning position need to have rigging points on the structure when a crane or bucket truck cannot be used. With a suspension insulator hanging from an arm, additional vang holes to attach rigging are needed. With a braced post insulator, a shield wire arm may be needed above to attach the rigging for the conductor.

Line angle must always be considered for rigging attachments in conjunction to the vangs and attachments. Just as a suspension insulator will swing into the line angle, the rigging lines will also swing as they temporarily hold the wire. The rigging attachments need to follow the swing angle of the wire up and back to a fixed point on the structure.

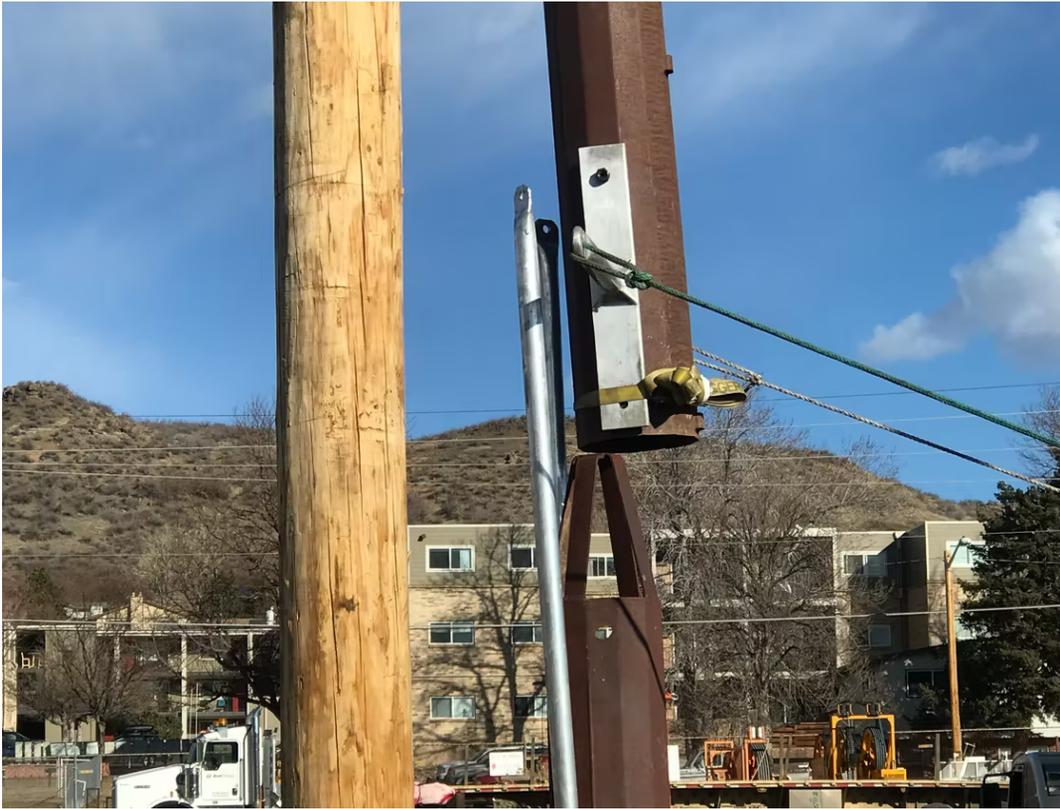
Helicopter Guide: New construction tool developed to aide in helicopter setting.

While the construction was still underway, the engineers onsite met with a few linemen in the crew to talk about how certain tools or design modifications could have made the construction process easier and safer. One of the linemen began to draw on the face of one of the steel poles a sketch of a tool that could be fabricated to allow the top pole section to be more efficiently guided and indexed onto the bottom pole section.

The first iterations were scrapped, but this allowed the group to focus in on a removable tool that bolts onto each pole section and acts like a goal post to guide the pole section down. Once back in the office the design was drafted in CAD and the material was selected based on what was available in an Xcel Energy material yard. The raw material that was used was from leftover aluminum bus work and an aluminum lattice tower that had been taken down. The end result was a lightweight, removable, helicopter guide tool.

The “top guide” bolts onto the jacking nuts of the base of the top pole section and is made of two aluminum arms that project horizontally about 2 ft (0.6 m). The arms serve two purposes. The first is for attaching the tag lines out on the arm ends to handle and index the pole easier and safer given the increased leveraged of the longer arms. The second purpose of the top guide arms is to provide increased material area to hit and slide down the “bottom guide” on the bottom pole section.
